# Test Report

Contract No : 23051002B-R1  
Issue Date : May 22, 2023  
Applicant : KING RITZ ENTERPRISE CO., LTD.  
Address : 11-11, Sihyue Rd, Houli Dist, Taichung  
City 421017, Taiwan R.O.C.  
Product : Differential  
Model No : YST-899-1-1  
Test Standard : As shown in the test report  
Test Results : As shown in the test report

Contract No. : 23051002B-R1

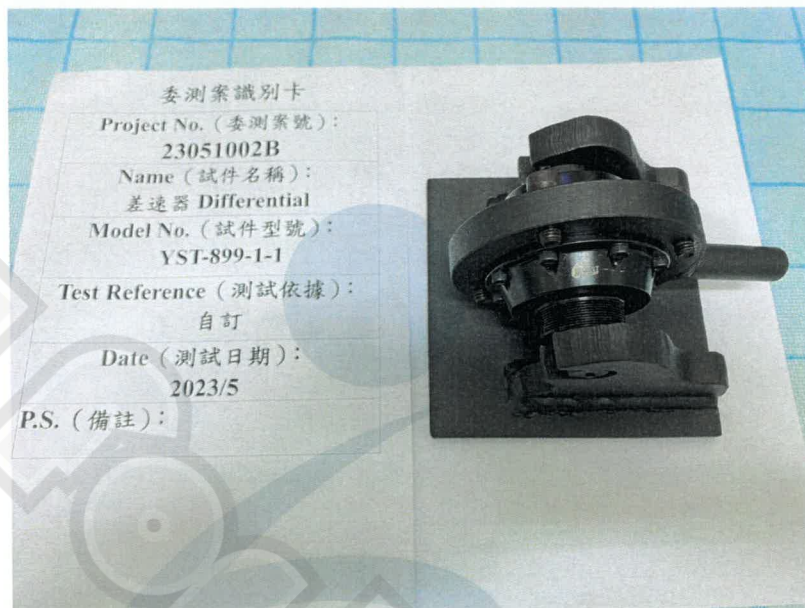
Fig. 1 Test sample

The sample is shown in Fig. 1. Specification of the sample is shown in Tab. 1.

| Sample | Specification | | Comments |
|---|---|---|---|
| Differential<br>(Model No : YST-899-1-1) | Material | Metal | --- |
| | Weight | 3760 g | |
